TWR - 17272, Vol. VI

FLIGHT SET 360L001 (STS-26) IGNITER,  
POST FLIGHT, FINAL REPORT

5 APRIL 1990

FLIGHT SET 360L001 (STS-26)  
IGNITER FINAL REPORT VOLUME VI

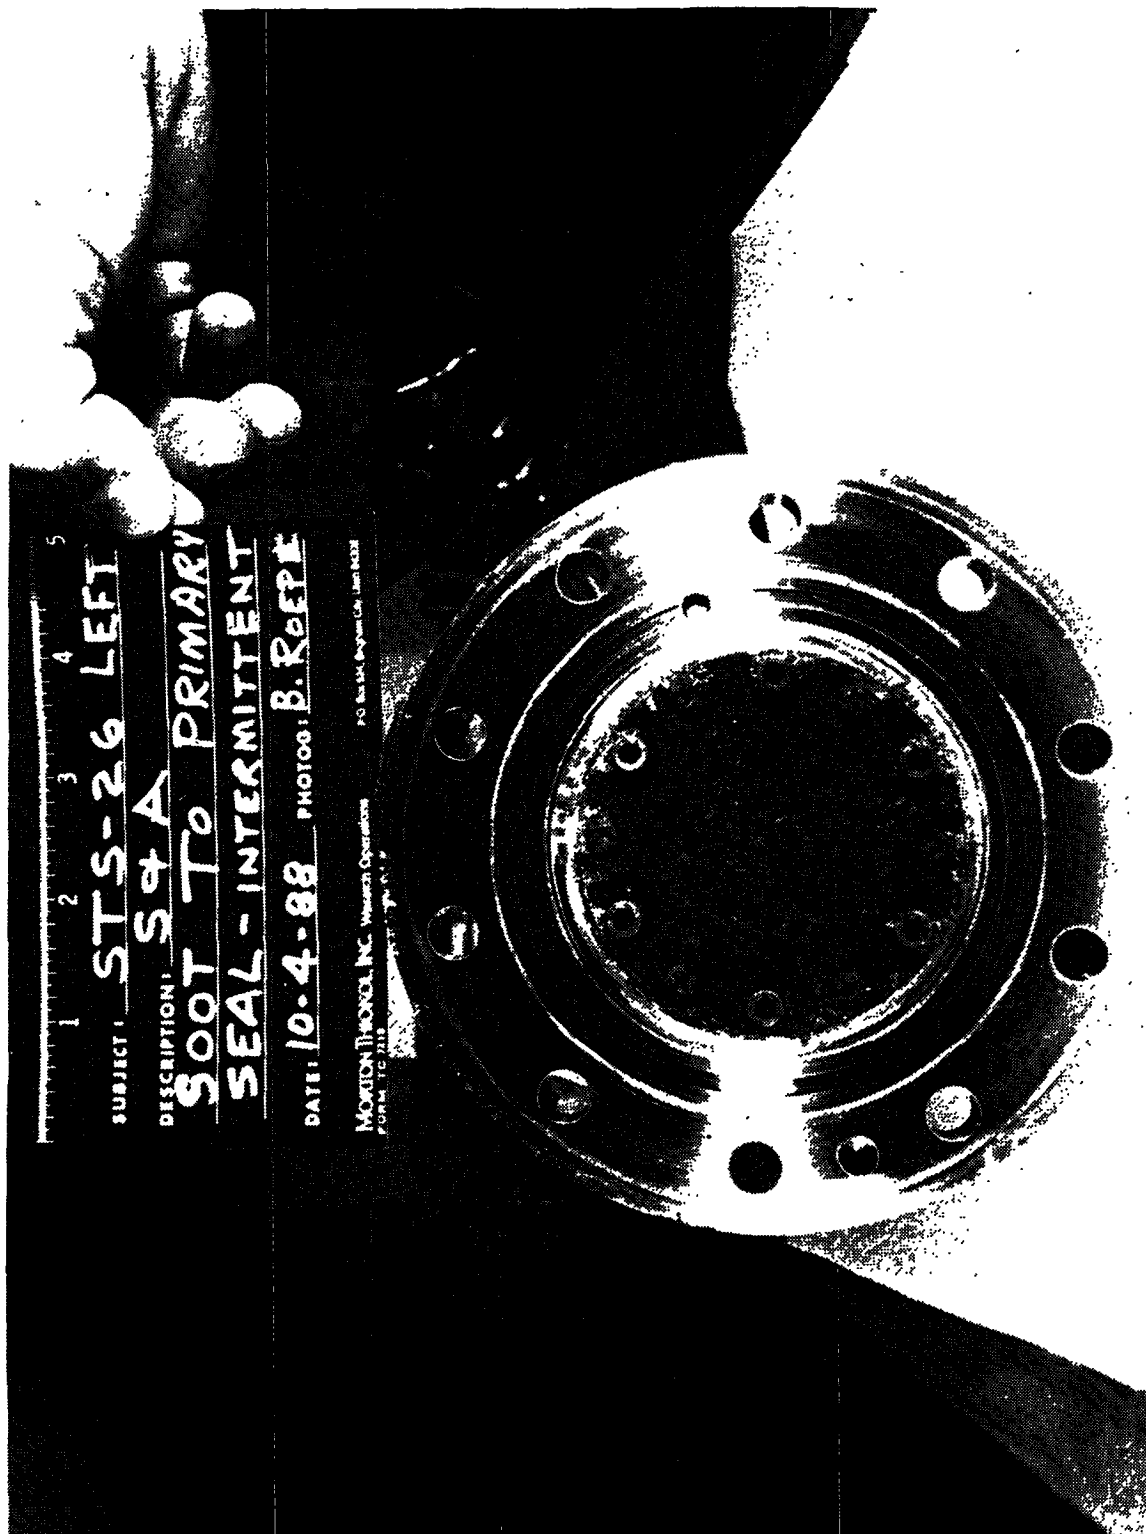
Figure 1. Safe and Arm Soot to Primary Seal Left Motor

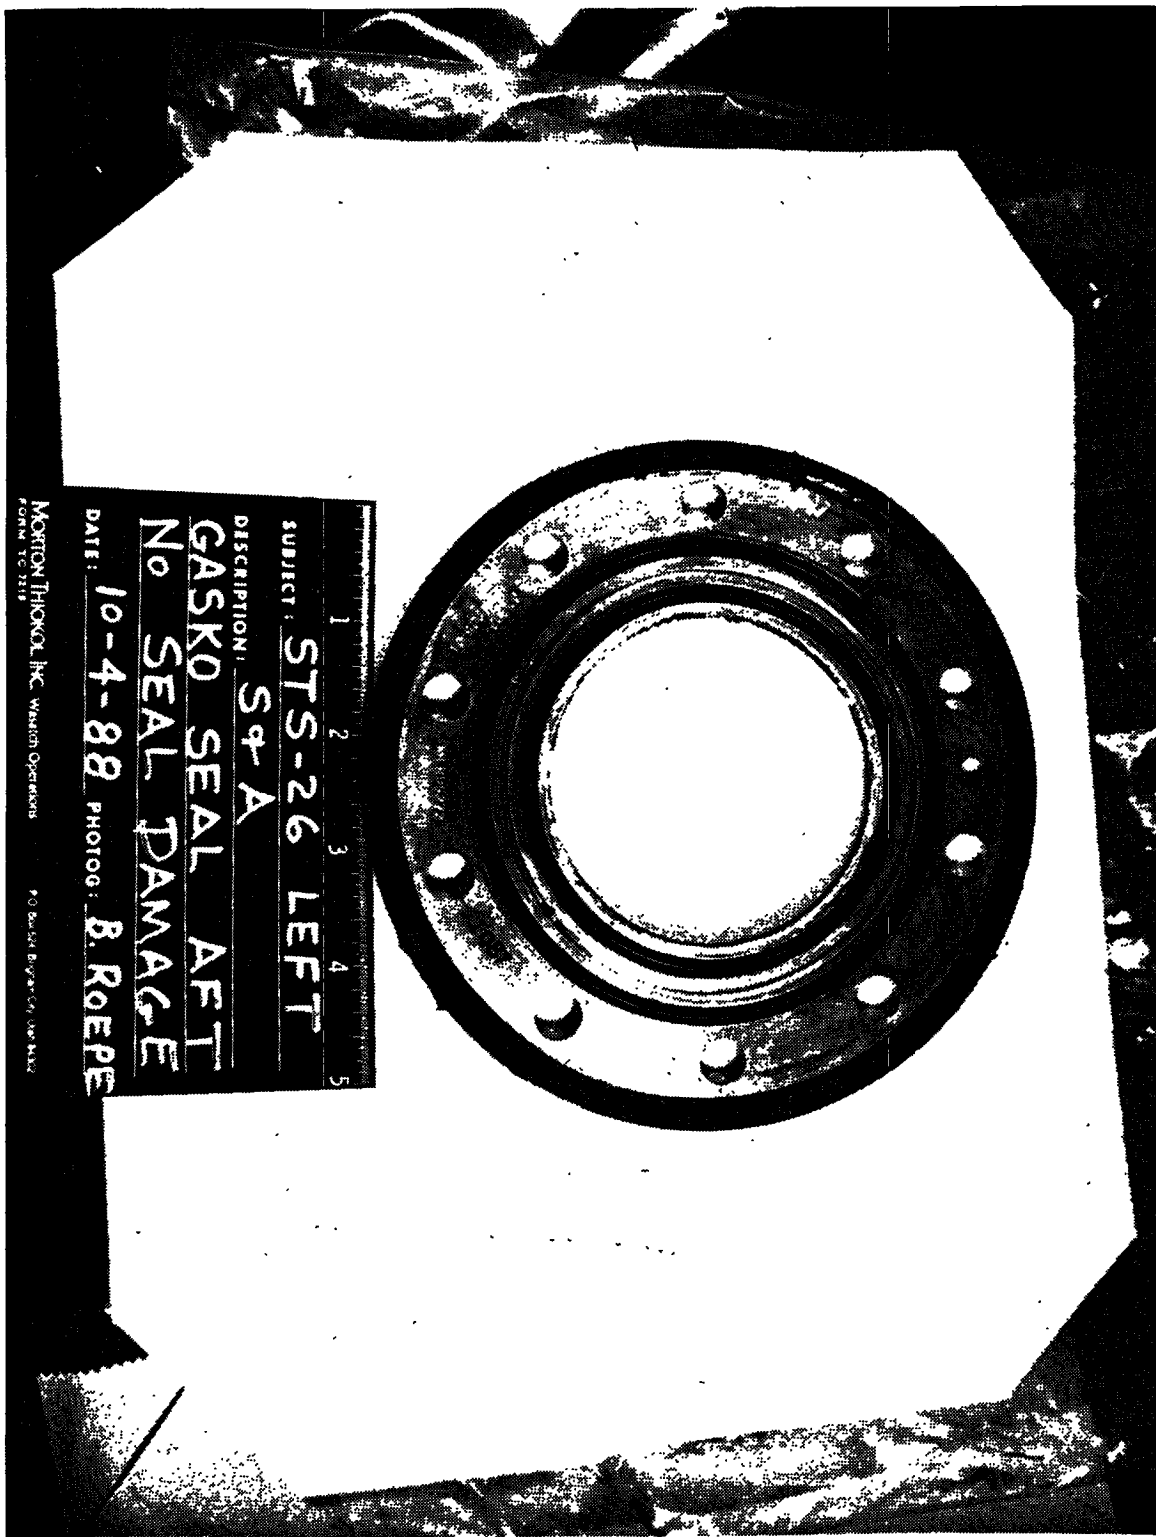
The grease application was not readily detectable on all surfaces. There was no grease on the seals. There was no evidence of hot gas past the primary seal on the safe and arm gasket. There was soot located intermittently on the aft side of the gasket and matching locations on the safe and arm from 125 to 195 degrees (70 degree arc), and from 200 to 270 degrees (70 degree arc). (Figure 1) The condition of the joint was nominal. There was no corrosion or damage found to the joint or gasket seals at disassembly. (Page B1 of Appendix B and Figure 2)

Figure 2. Safe and Arm Gasko Seal Left Motor

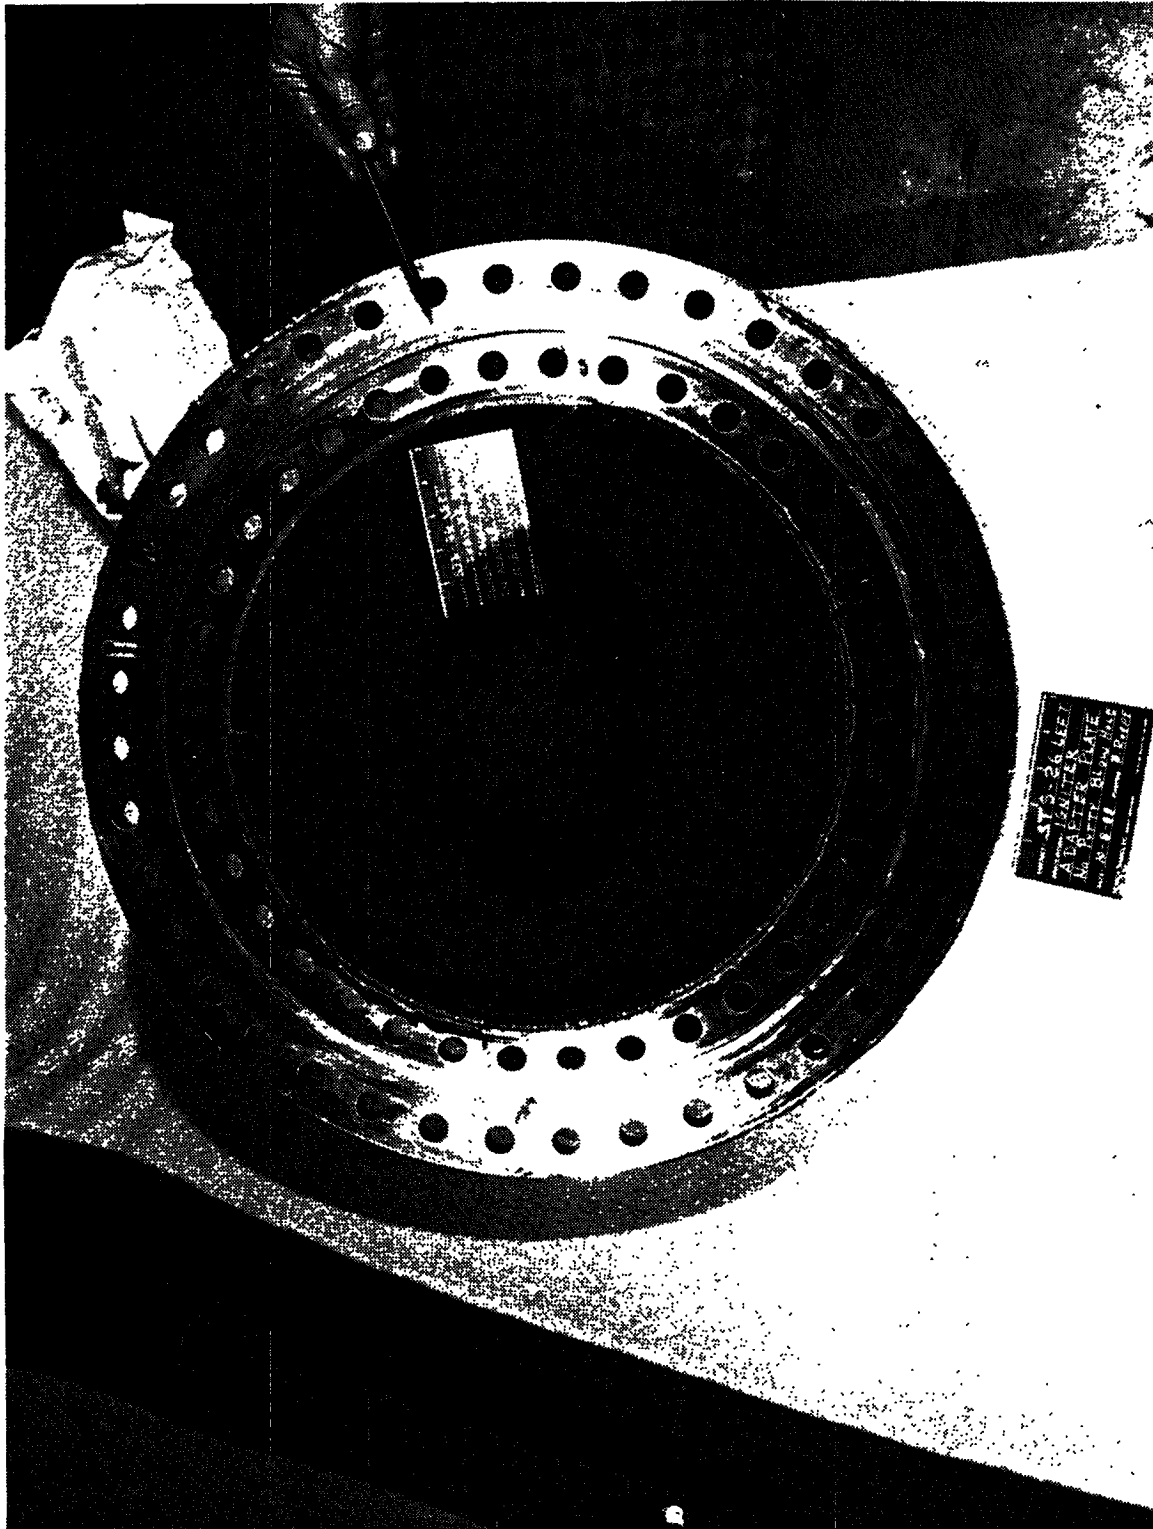
The grease was light and per design, however, there was light circumferential corrosion on the adapter plate, forward of the outer joint primary seal and in the region between the inner seal and outer seal. (Figure 3) There was corrosion on the tips of all transducer bolts and in the bottom of all transducer bolt holes located at 40, 100, 180, and 270 degrees. (Figure 4) This corrosion will not cause a refurbishment problem because it is not on the sealing surfaces.

Figure 3. Igniter Adapter Plate Corrosion Left Motor

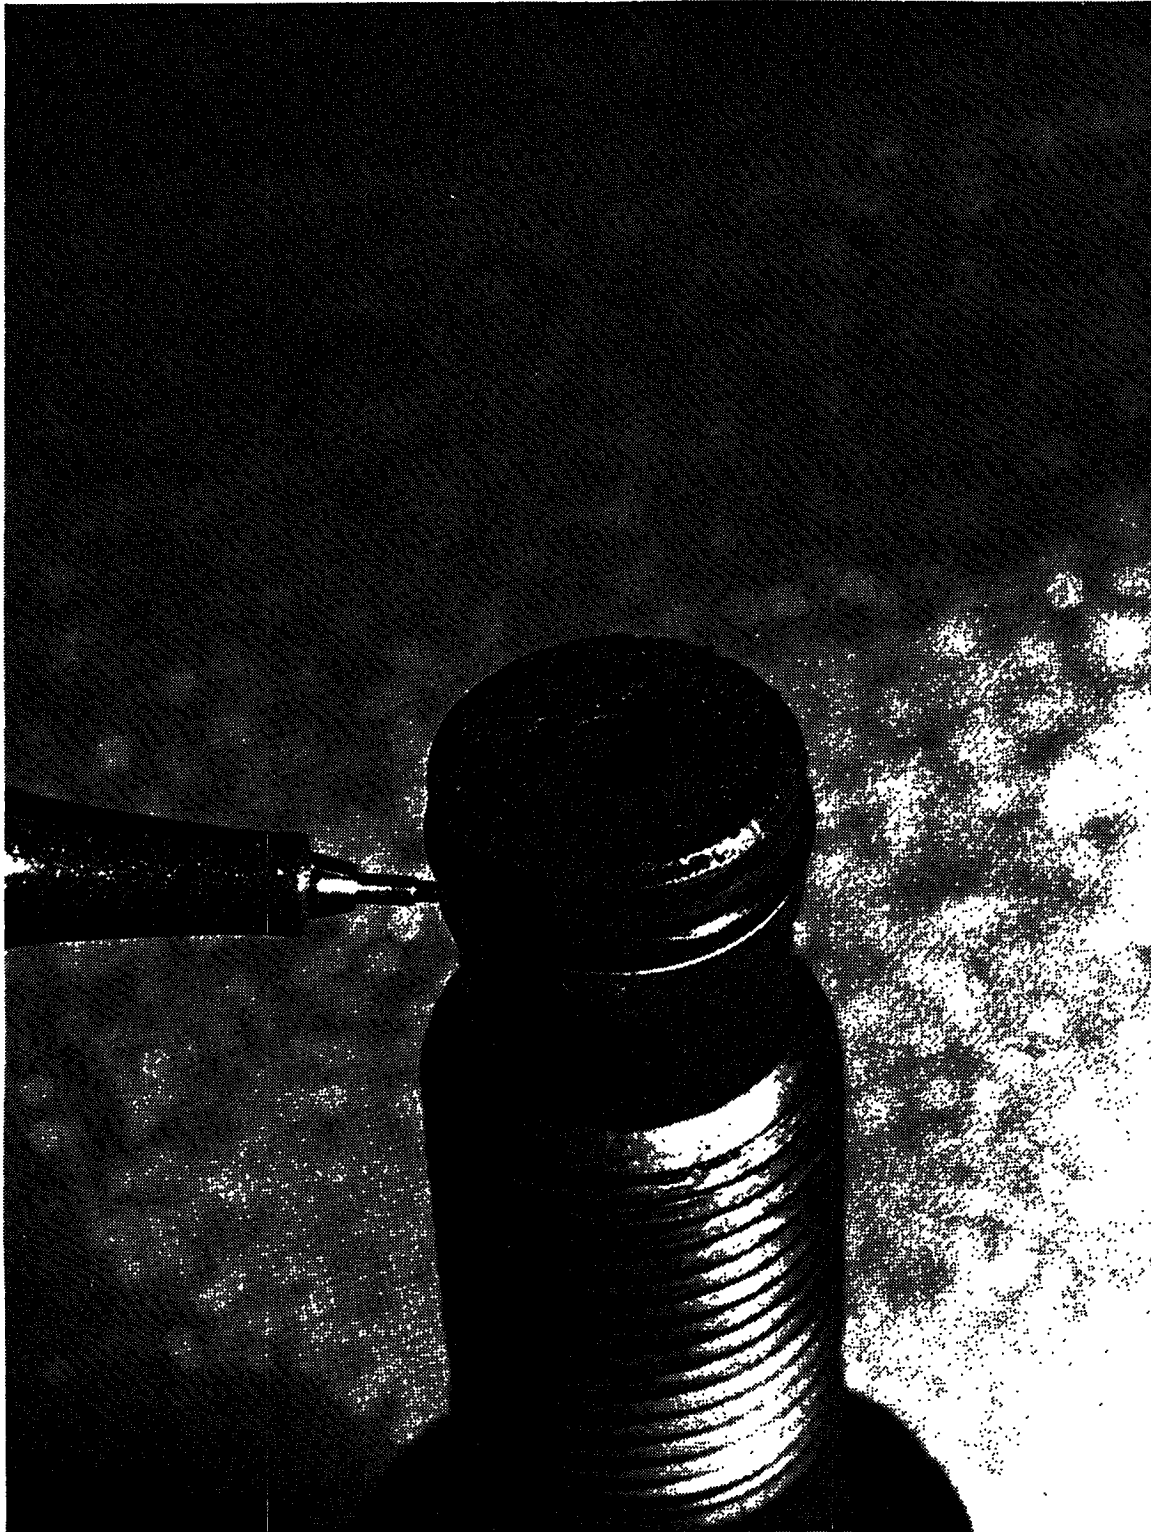
Figure 4. Igniter Transducer Bolt Corrosion

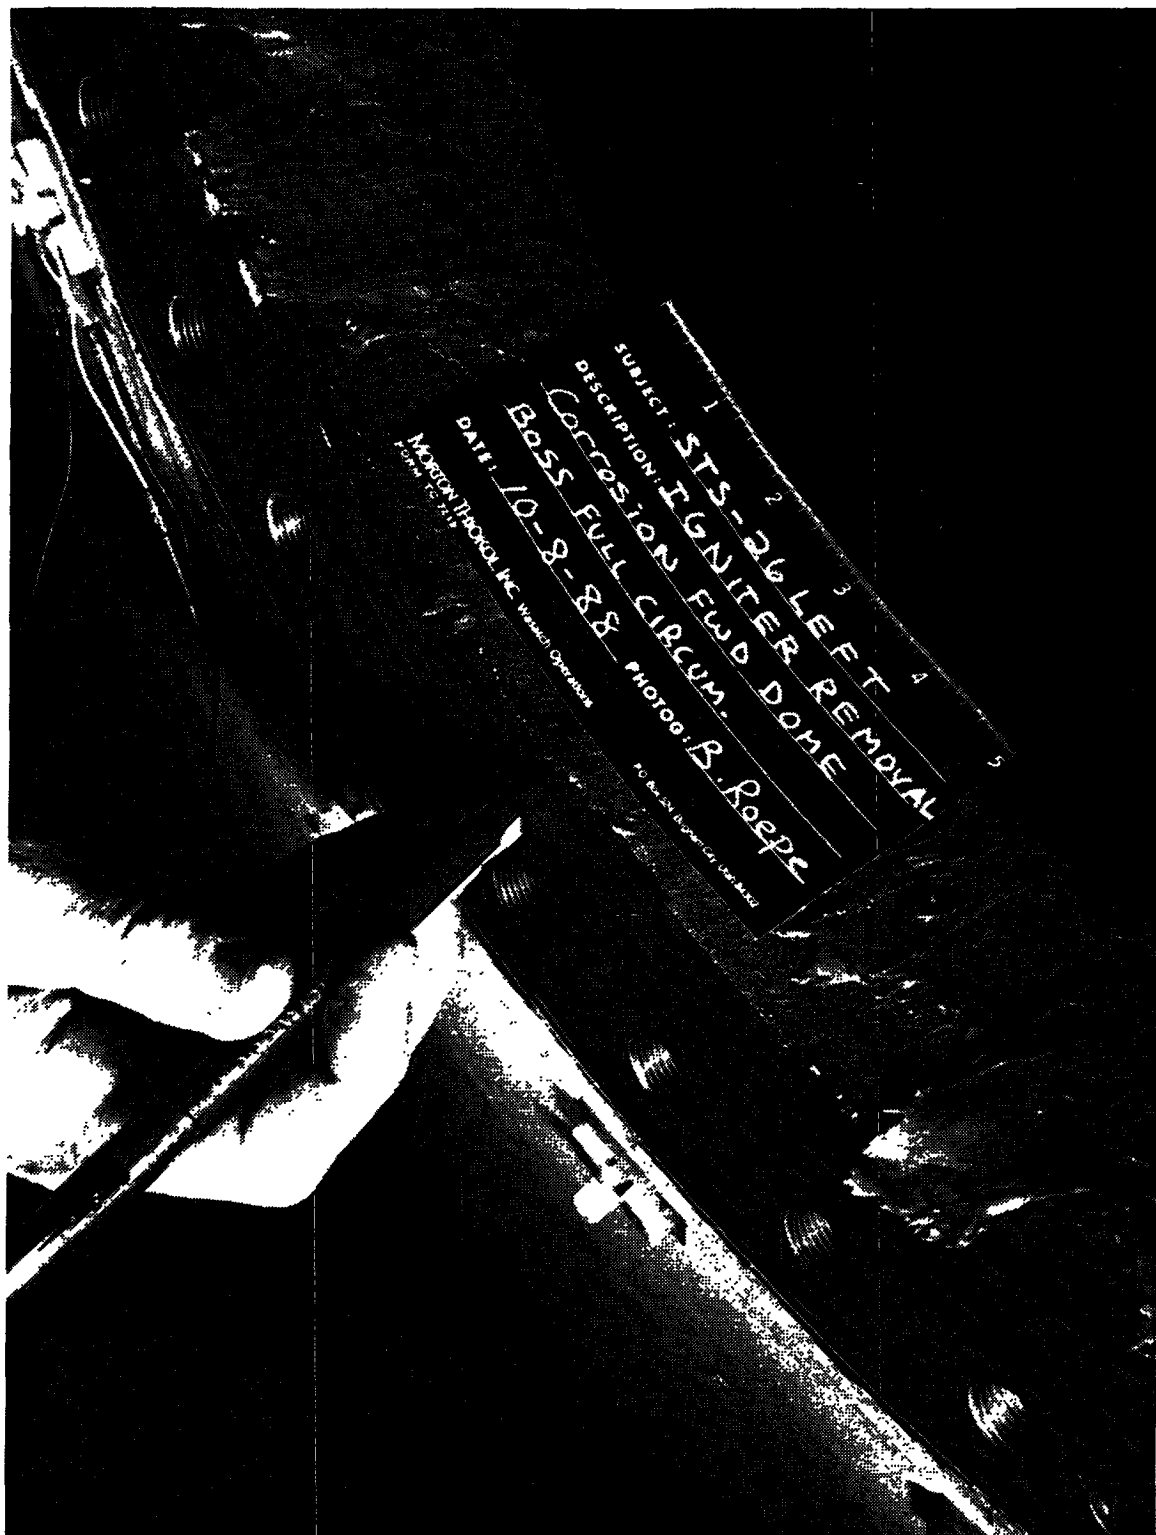
No evidence of hot gas leakage past the primary seal or damage on the joint or gasket seals was found. There was corrosion around the full circumference on the inside diameter of the forward dome boss and over the edge to the inside. Most of the corrosion was very light with a few heavier areas. None of the corrosion seen will affect the components ability to be refurbished. (Figure 5)

Figure 5. Igniter Forward Dome Boss Corrosion Left Motor

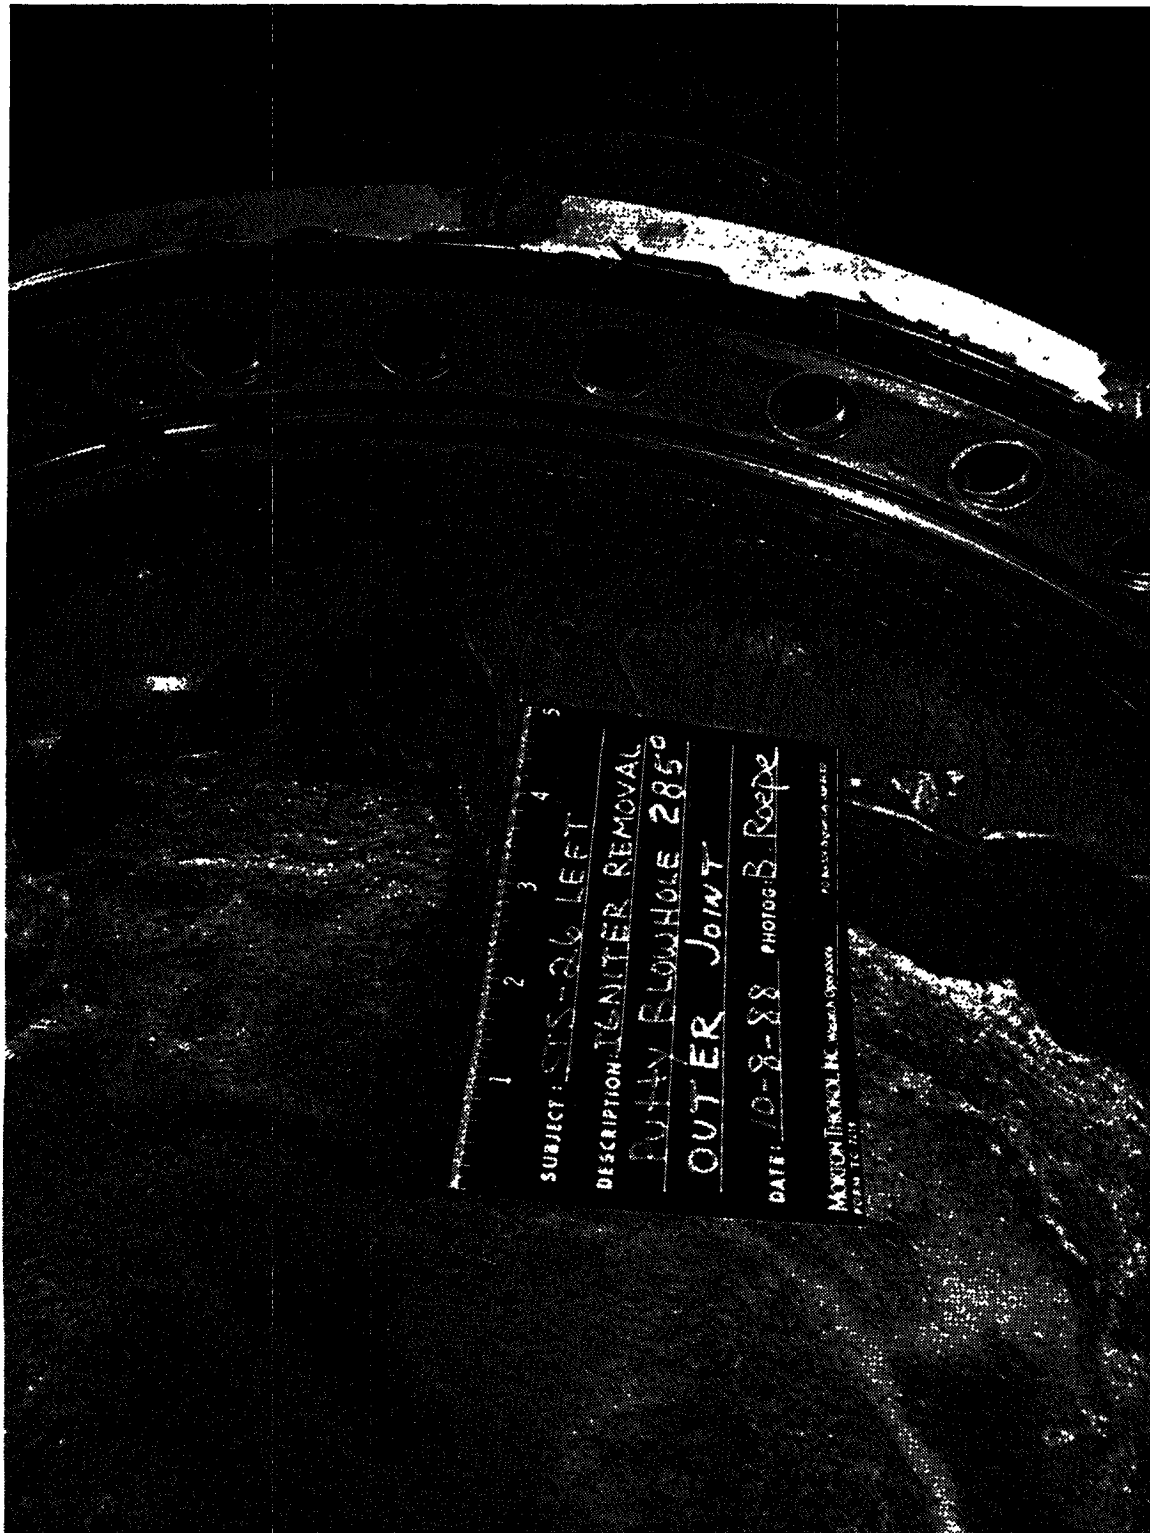
A putty blowhole was observed at 285 degrees, which was 1.625 inches wide at the entrance with 0.75 inch mid-width and 1.5 inch outlet width. (Figure 6)

Figure 6. Igniter Putty Blowhole Left Motor

Decision was to continue to use the present design.

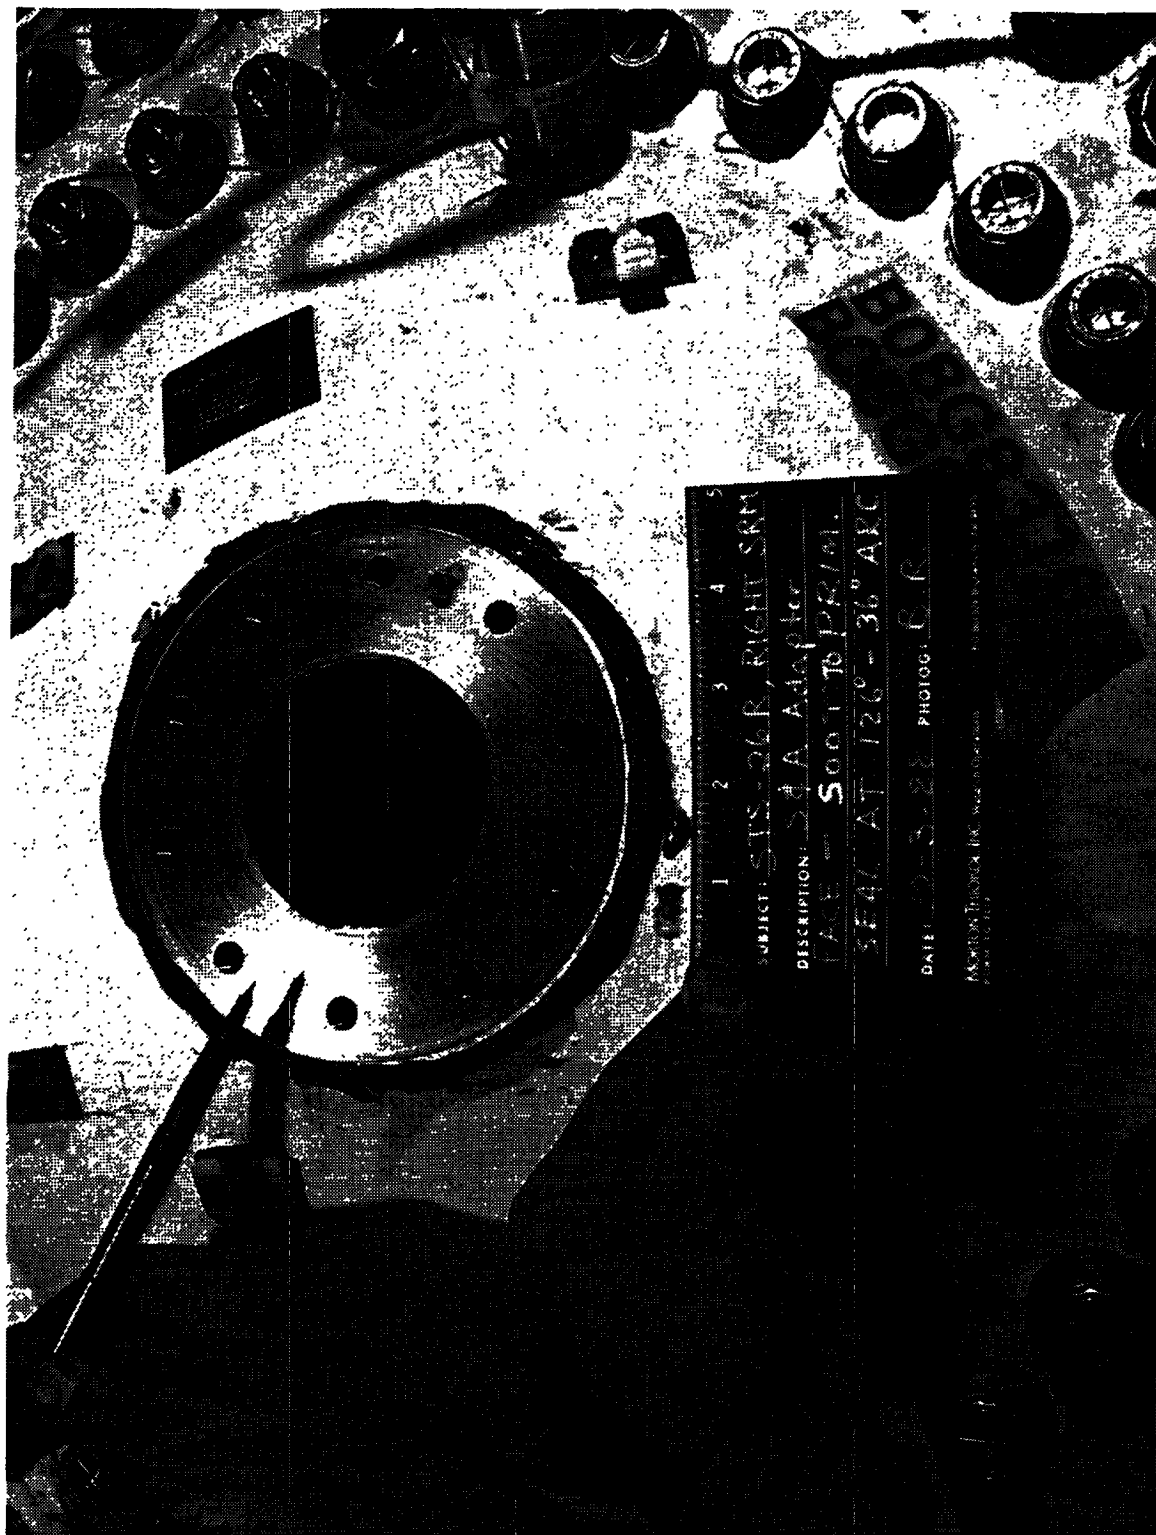
No evidence of hot gas past the primary seal on the Safe and Arm gasket was found. Soot was found on the primary seal on the aft side of the gasket from 108 to 144 degrees (36 degree arc). Soot was barely detectable on the gasket and was more evident on the igniter adapter surface. (Figure 7)

Figure 7. Safe and Arming Adapter Soot Right Motor

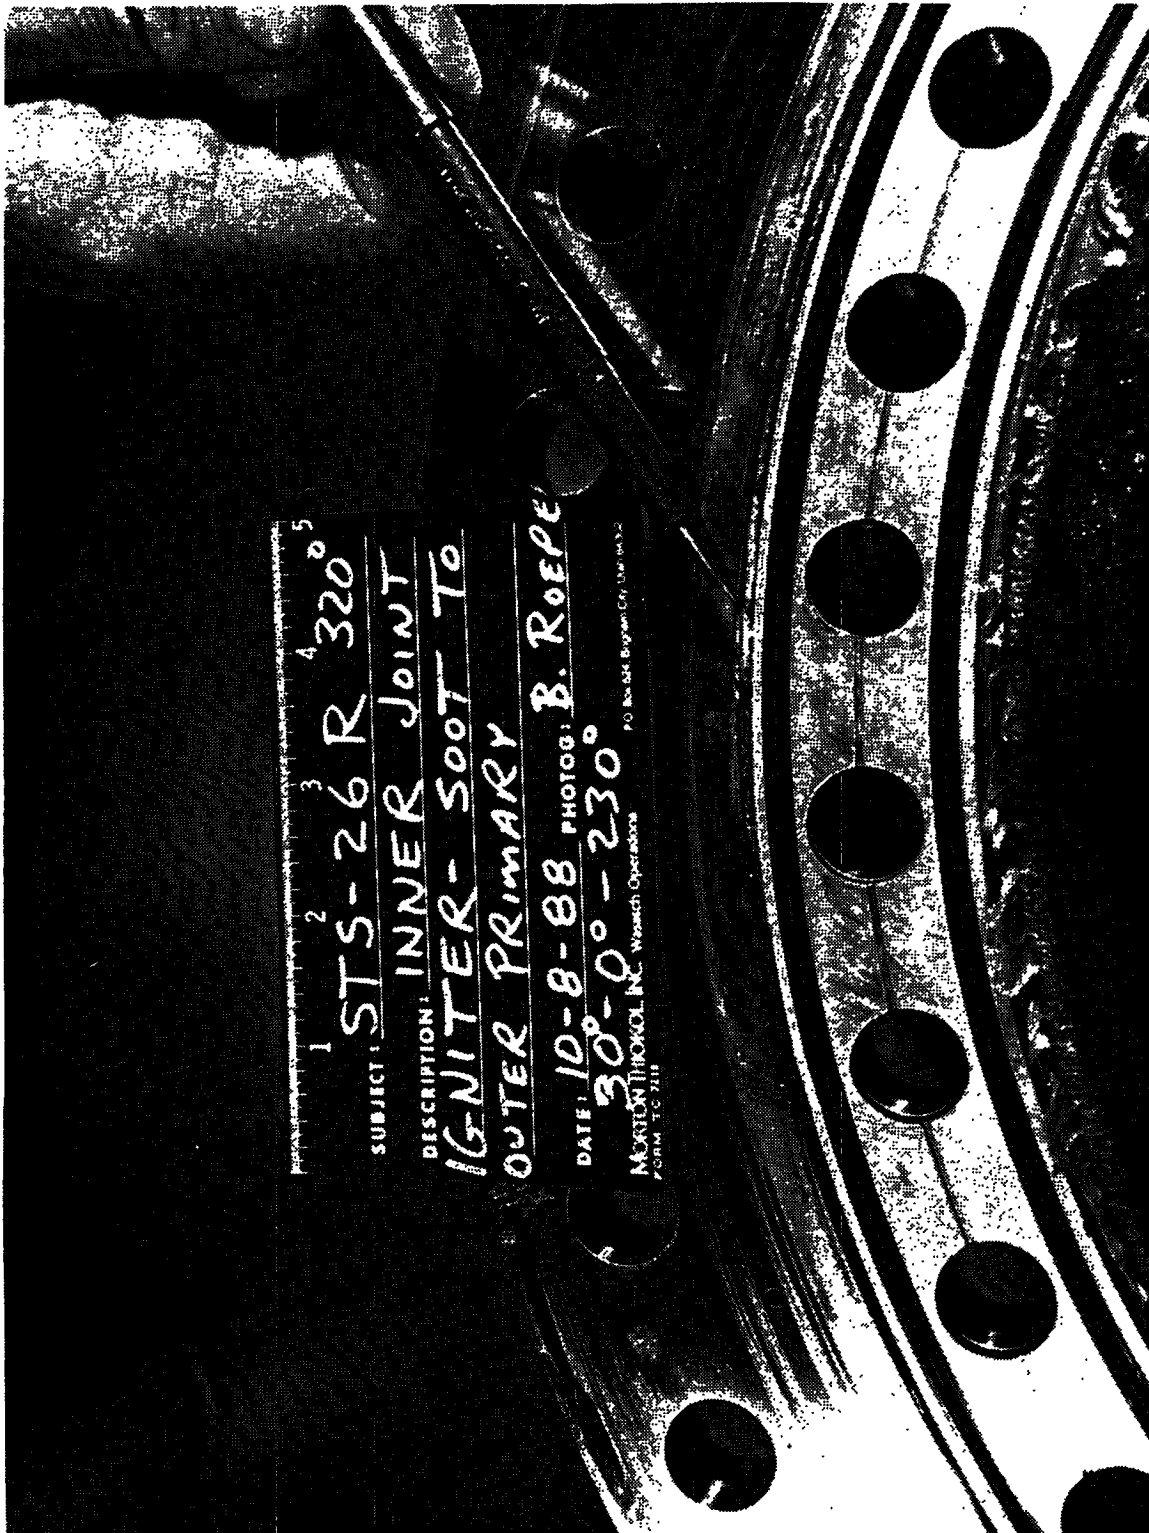
No blow holes were found in the putty, therefore, no soot reached the inner primary seal. Light soot was found leading to the outer primary seal on the aft side of the inner gasket around the full circumference, and heavier soot was found from 30 to zero to 230 degrees (160 degree arc). (Figure 8)

Figure 8. Igniter Inner Joint Soot Right Motor

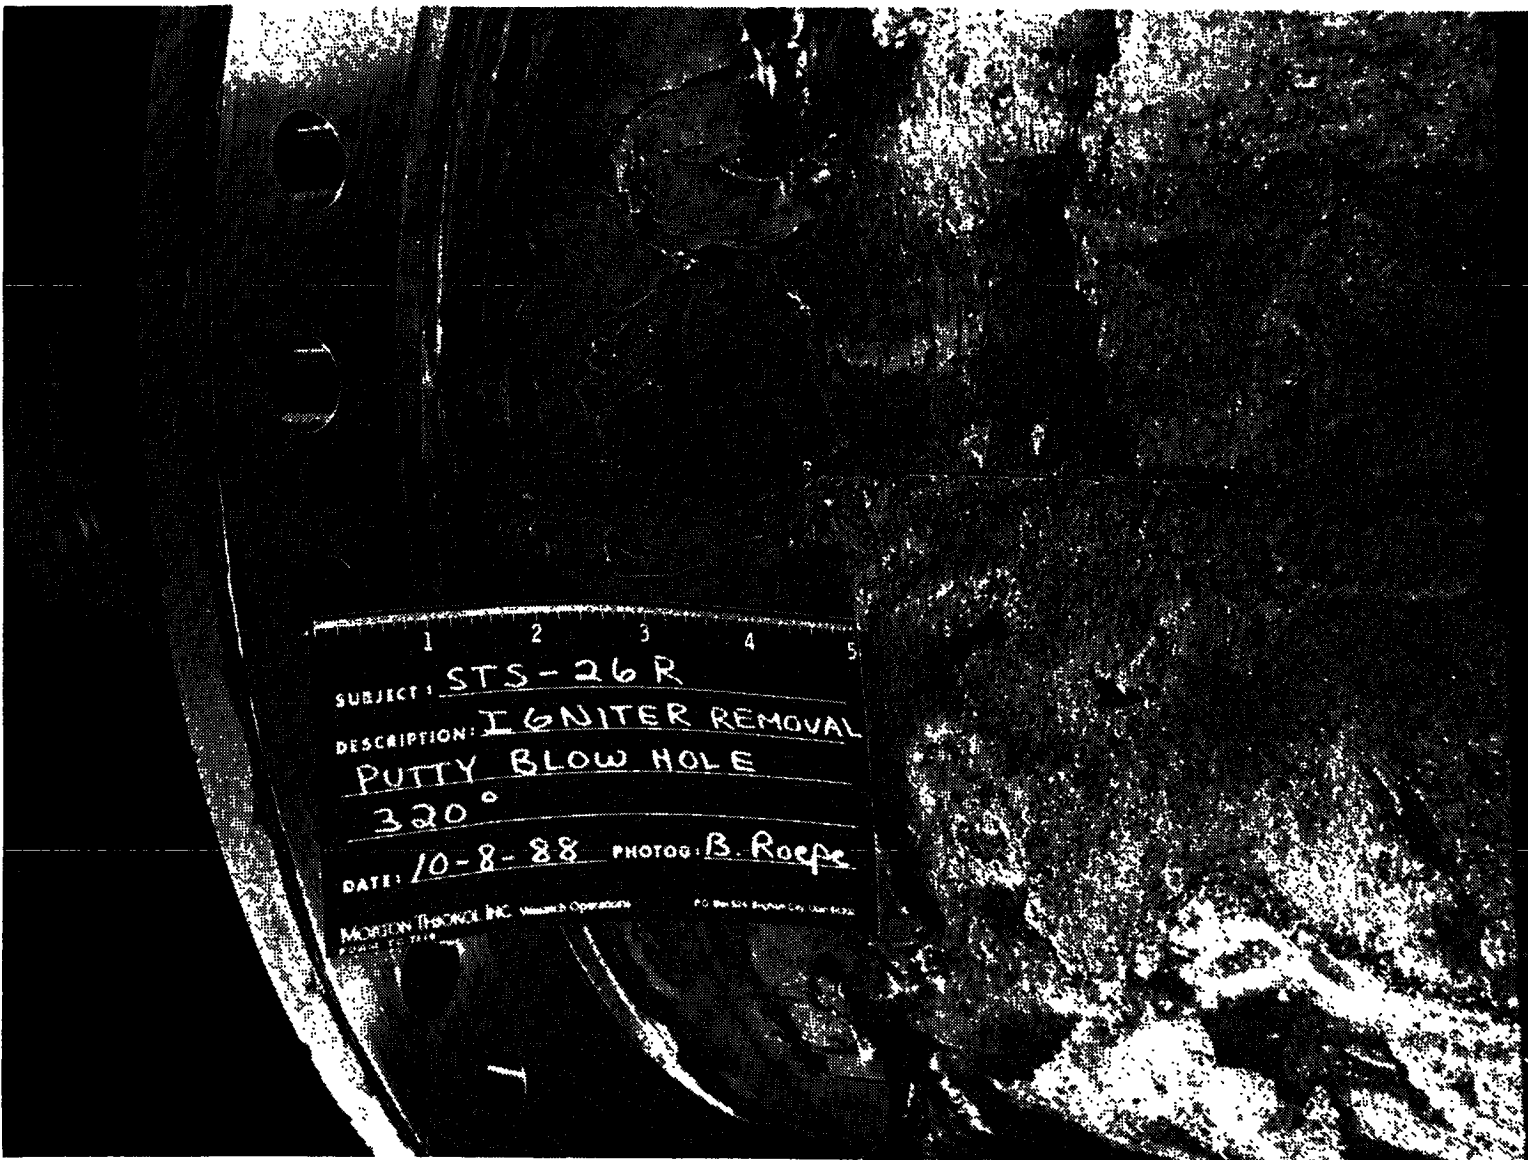
No evidence of hot gas leakage past the primary seal and was found and no seal damage was observed on the gasket. A putty blow hole was observed at 320 degrees. (Figure 9) It was 1.0 inch wide at the entrance and necked down to 0.625 inch at the exit. This blowhole is typical of what has been seen before. (Page B5 and B6 of appendix B)

Figure 9. Igniter Putty Blowhole Right Motor

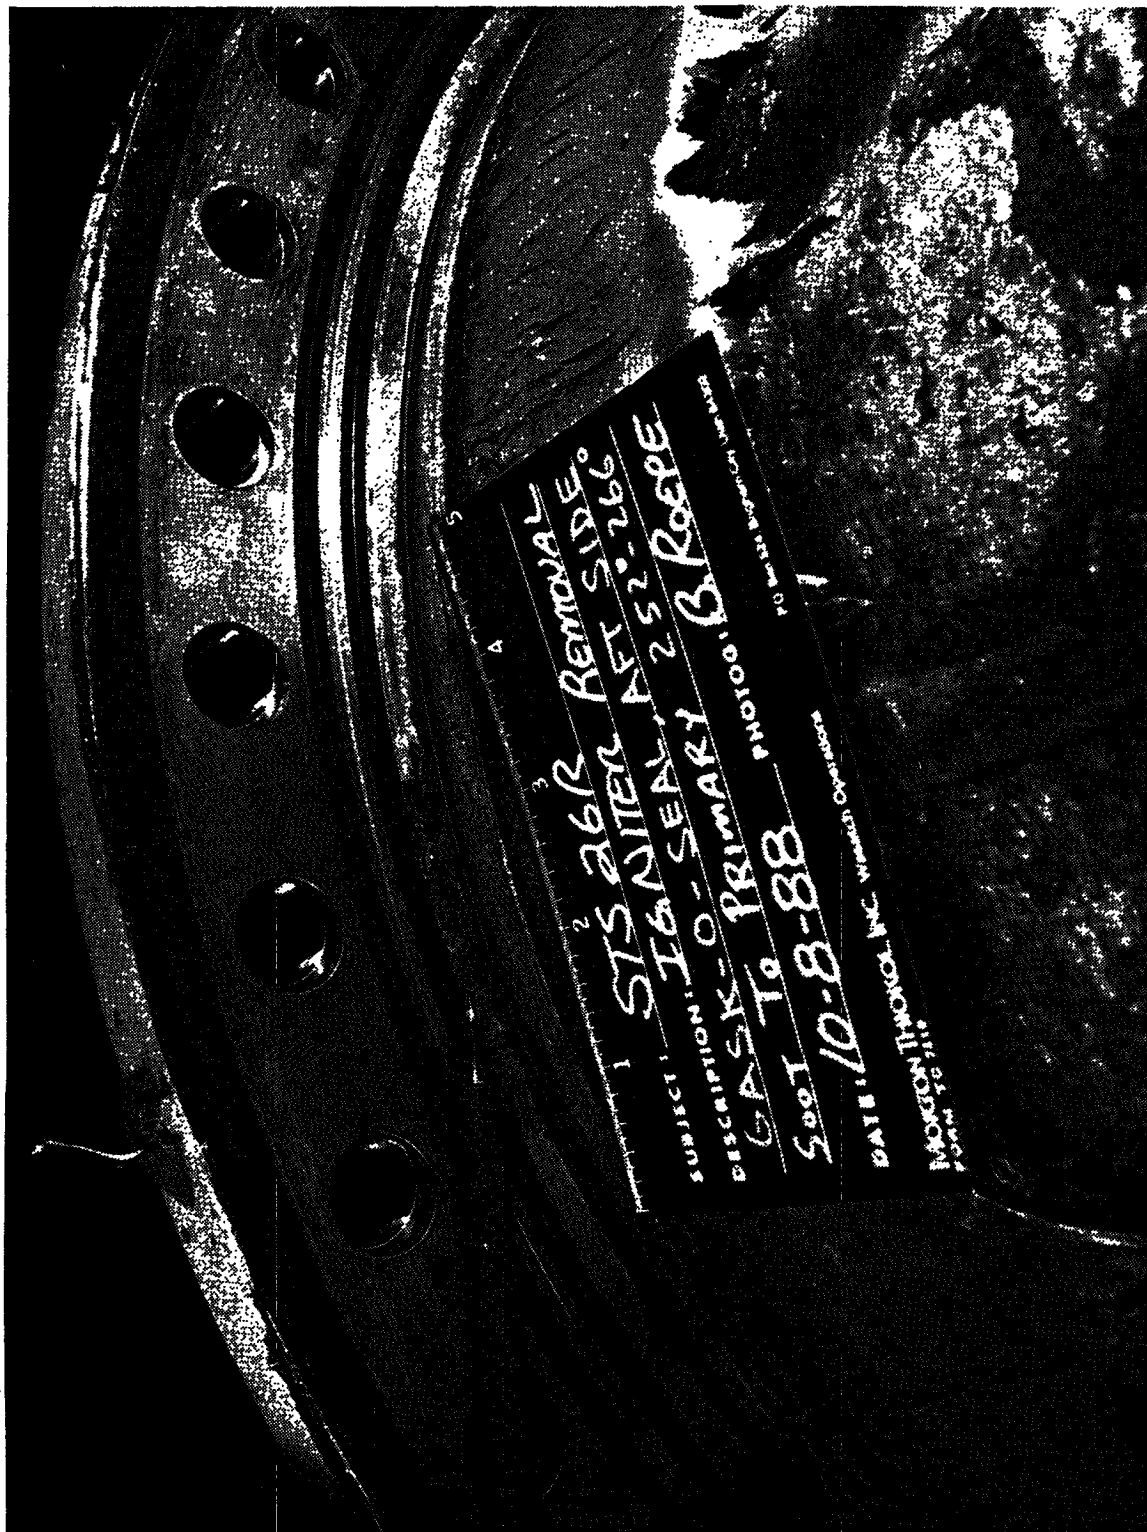
On the aft face of the gasket, there was light soot to the primary seal from 162 to 252 degrees (90 degree arc), and heavier soot to the primary seal from 252 to 266 degrees (14 degree arc). The forward face showed intermittent soot to the primary seal from 240 to 340 degrees (100 degree arc), and light soot intermittent over the edge to the primary seal over the full circumference. (Figure 10)

Figure 10. Igniter Gask-O-Seal Soot Right Motor

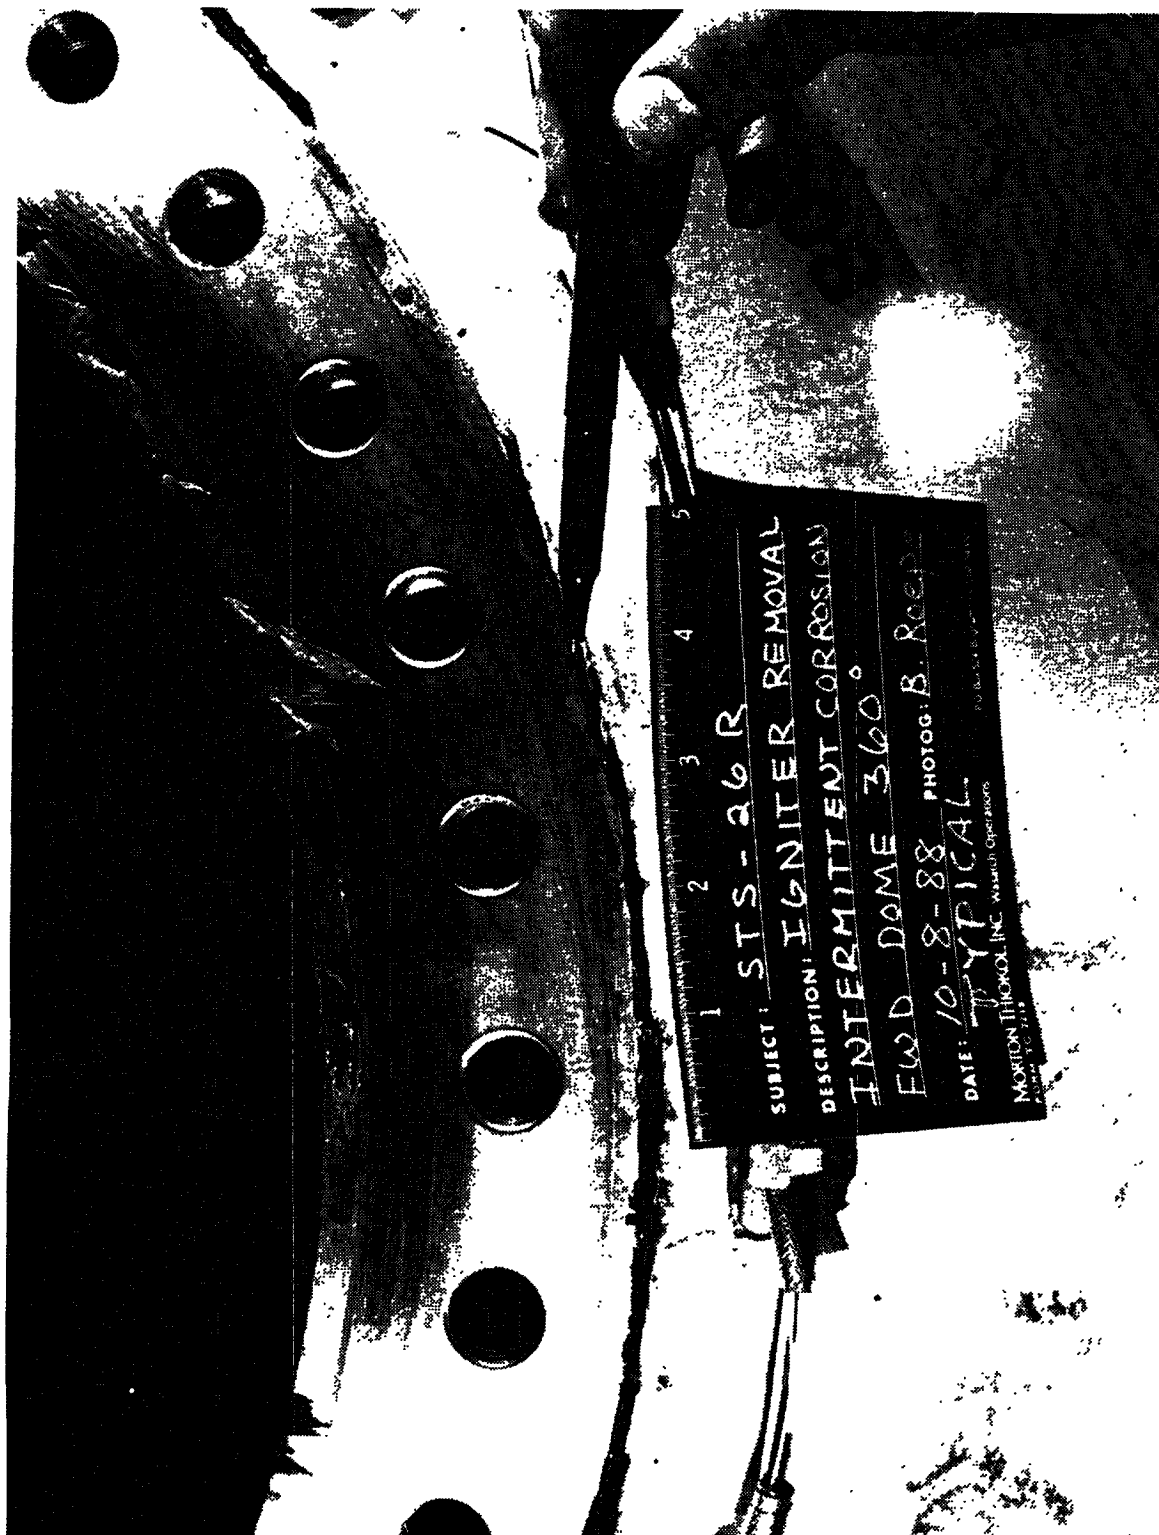
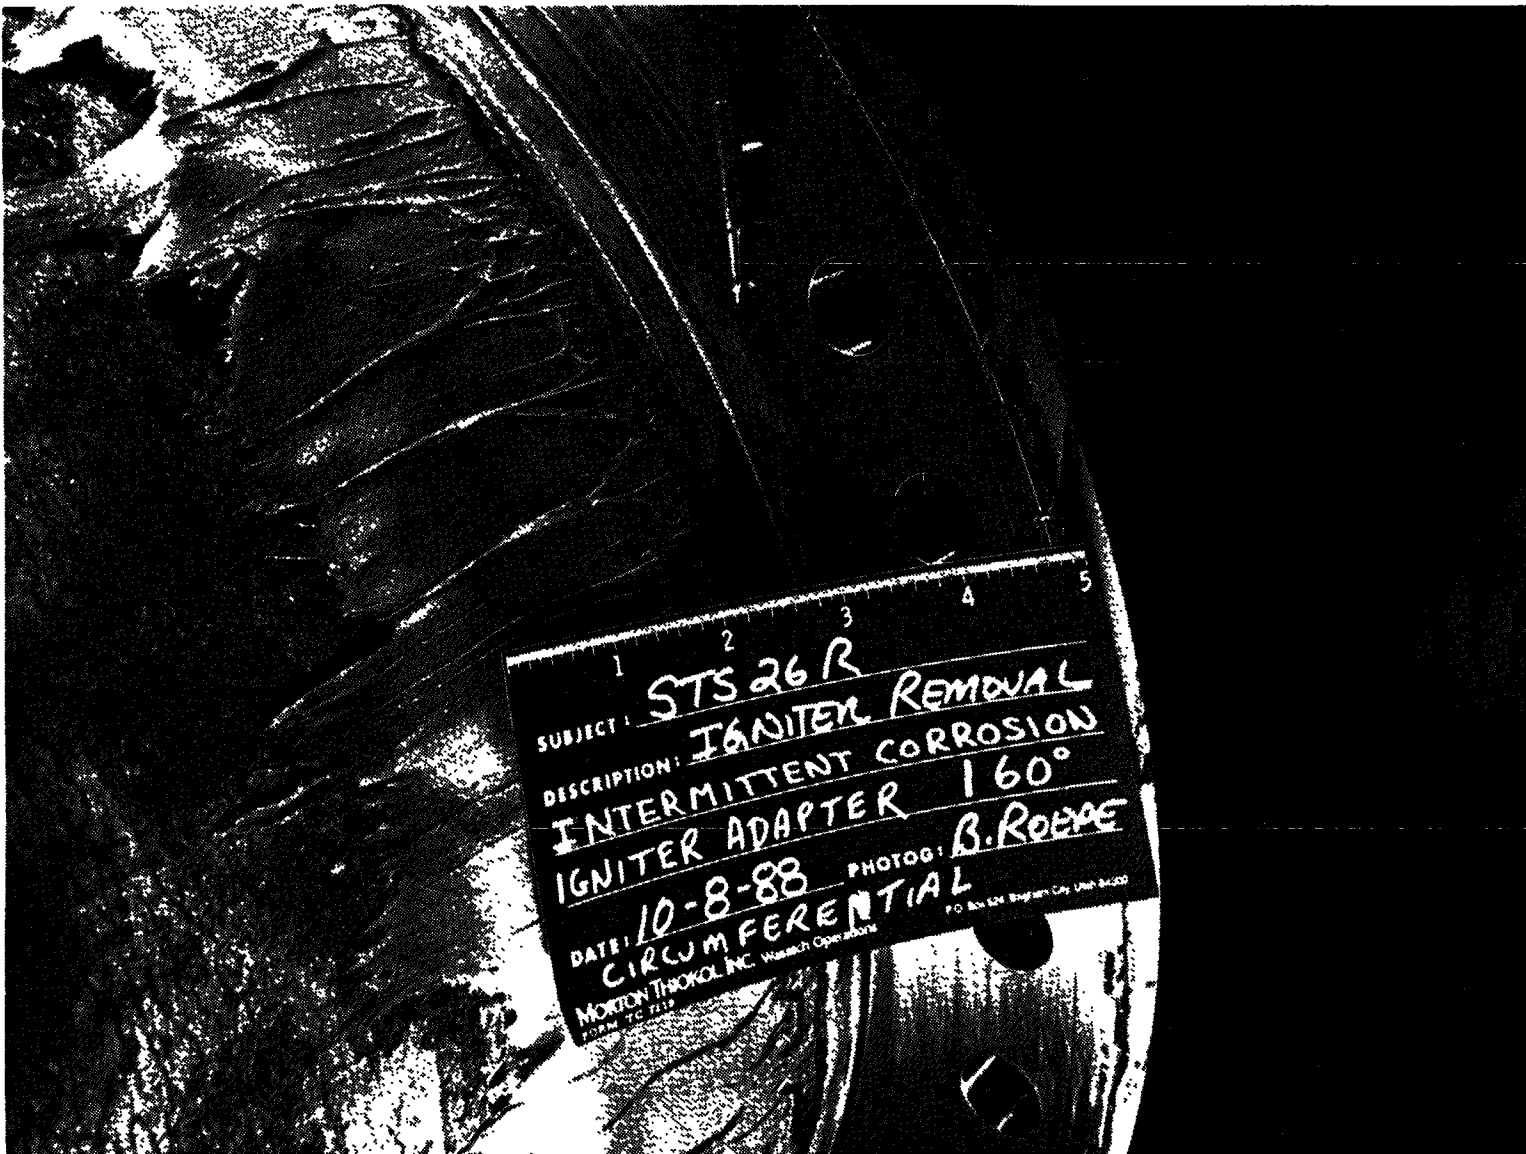
Corrosion was found on the inside edge of the forward dome boss and outside edge. This corrosion has been seen in the past. The corrosion occurs when the gases from the motor fill the volume past the putty and when sea water enters this cavity. The corrosion seen at this time will not affect the components ability for refurbishment. (Figure 11 and 12)

Figure 11. Forward Dome Corrosion Right Motor

Figure 12. Igniter Adapter Corrosion Right Motor
